Home Inspection Report

AnyTown, NC

Inspection Date:
05/06/2010

Report Number:
7302025

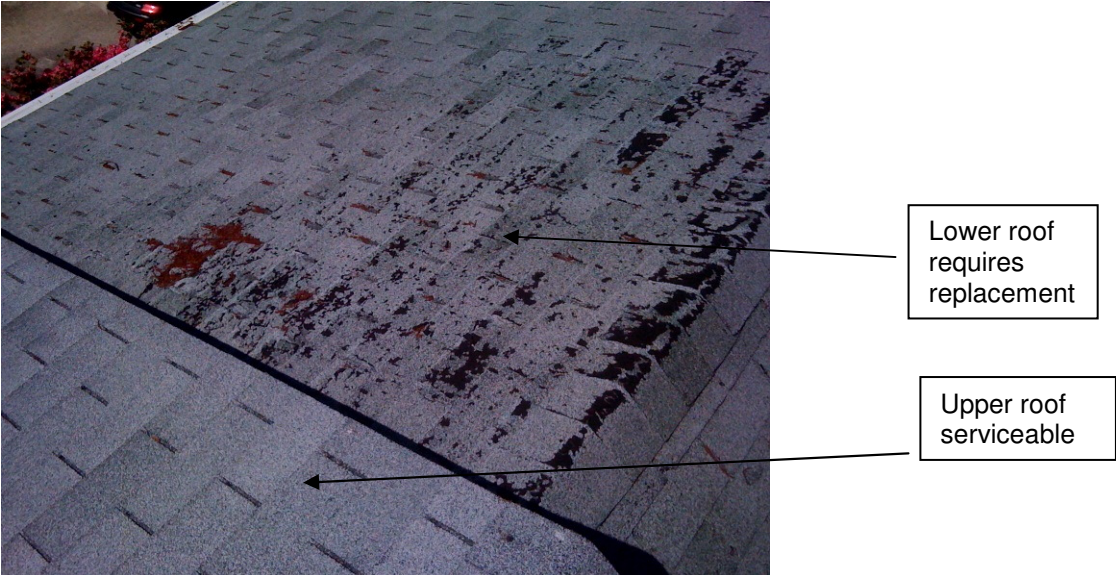
- **Repair:** Damaged shingles at the rear roof should be repaired or replaced to prevent moisture penetration to the materials below.

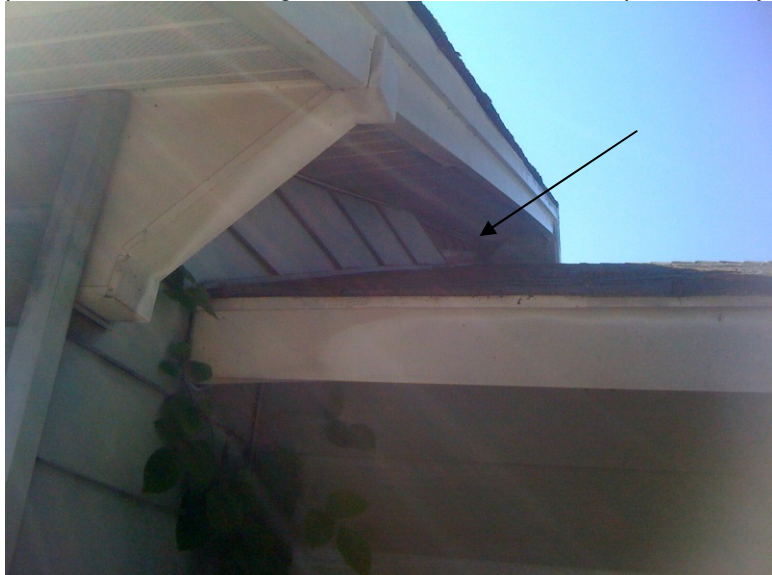
- **Repair:** The crawl space door damaged and should be repaired or replaced to prevent vermin entry.
- **Repair:** The siding is damaged or missing at the rear upper roof. This should be repaired or replaced to prevent moisture damage to the materials below. A qualified vinyl siding contractor should be engaged.

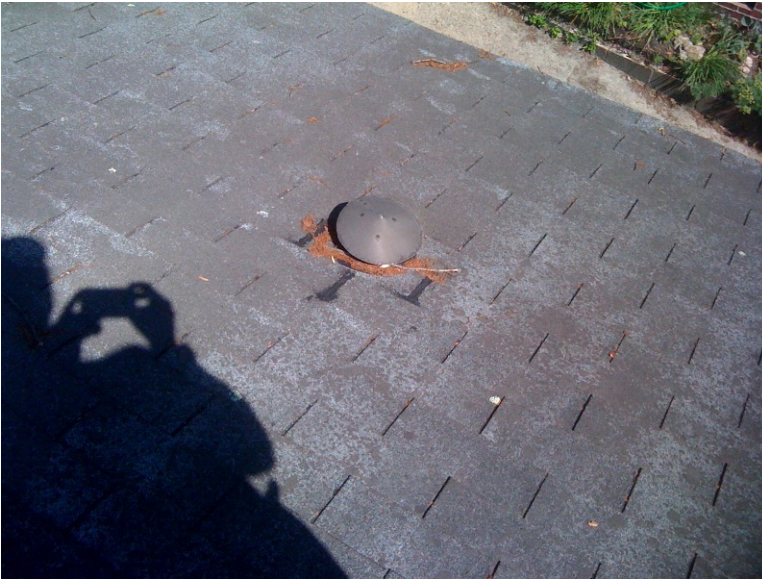
- **Repair:** The hose bib (exterior faucet) at the right side of the home is loose and should be properly attached to prevent damage to the plumbing.
- **Repair:** The vent stack that penetrates the roof should extend at least 6 inches above the roof and should be at least 2 inches in diameter.

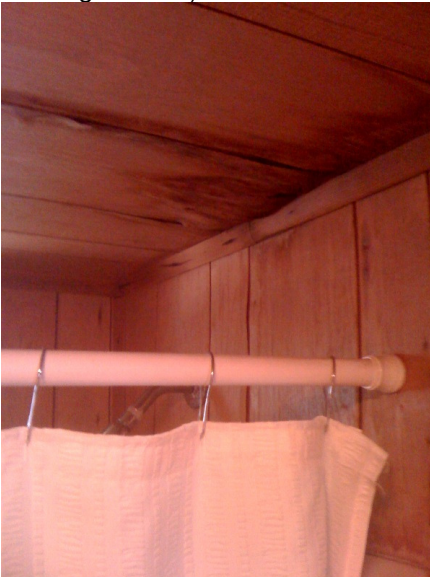
- **Repair:** Water damage was noted at the bathroom ceiling, possibly from a leaky plumbing boot (See Roofing Section).
